# Appendix 3 – Detailed Site Notes

## Location 1: 46 Wallace Gardens, Causewayhead

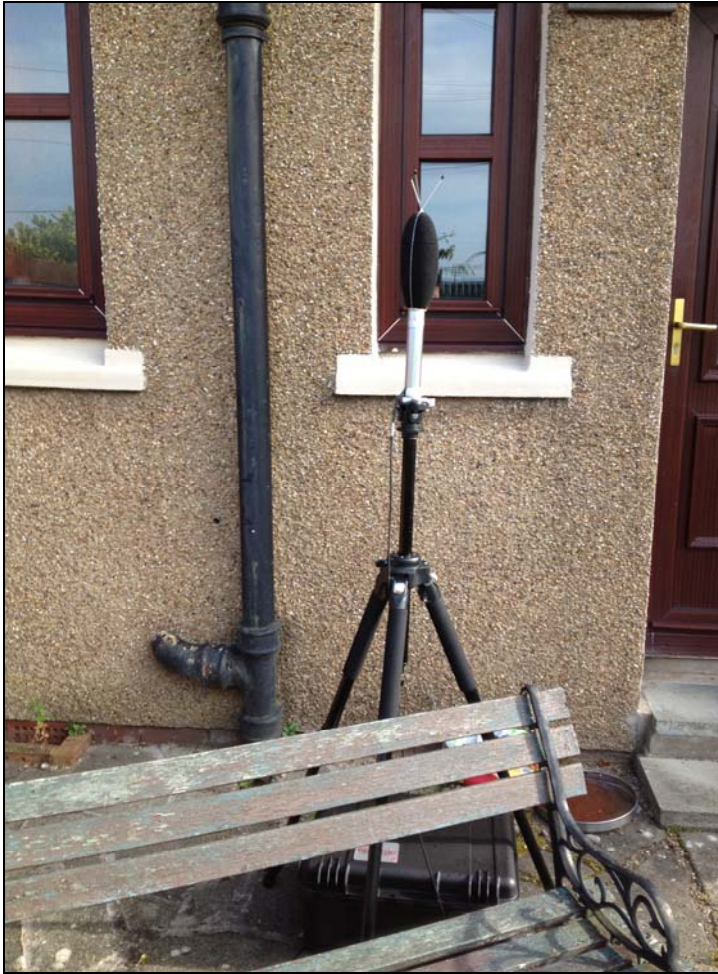
Photograph A.1: Measurement Location at 46 Wallace Gardens

The Brüel & Kjær 2250/2260 sound level meter was secured to a tripod with the microphone 1.5m above the ground, adjacent to the Rion NL-52/Brüel & Kjær 2250 sound level meter. The monitoring equipment was calibrated both before and after the measurement period using an acoustic calibrator, which has itself been calibrated against a reference set traceable to National and International Standards. There was no shift in the observed calibration level greater than 0.2 dB. Fifteen minute snapshot noise level measurements were undertaken with the Brüel & Kjær 2250 throughout the measurement procedure and are shown in Table A.1.

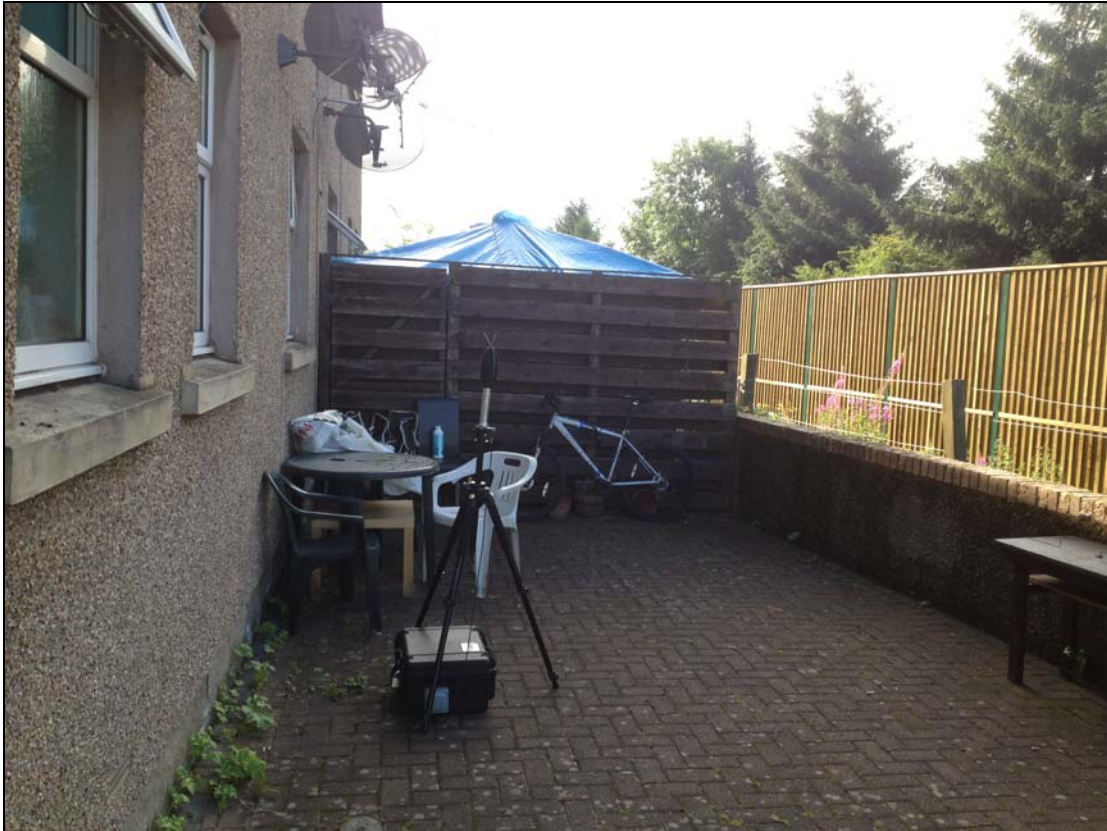
Photograph A.2: Measurement Location at 56 Alloa Road

The Brüel & Kjær 2250/2260 sound level meter was secured to a tripod with the microphone 1.5m above the ground, adjacent to the Rion NL-52/Brüel & Kjær 2250 sound level meter. The monitoring equipment was calibrated both before and after the measurement period using an acoustic calibrator, which has itself been calibrated against a reference set traceable to National and International Standards. There was no shift greater than 0.2 dB in the observed calibration level. Fifteen minute snapshot noise level measurements were undertaken with the Brüel & Kjær 2250 throughout the measurement procedure and are shown in Table A.2.

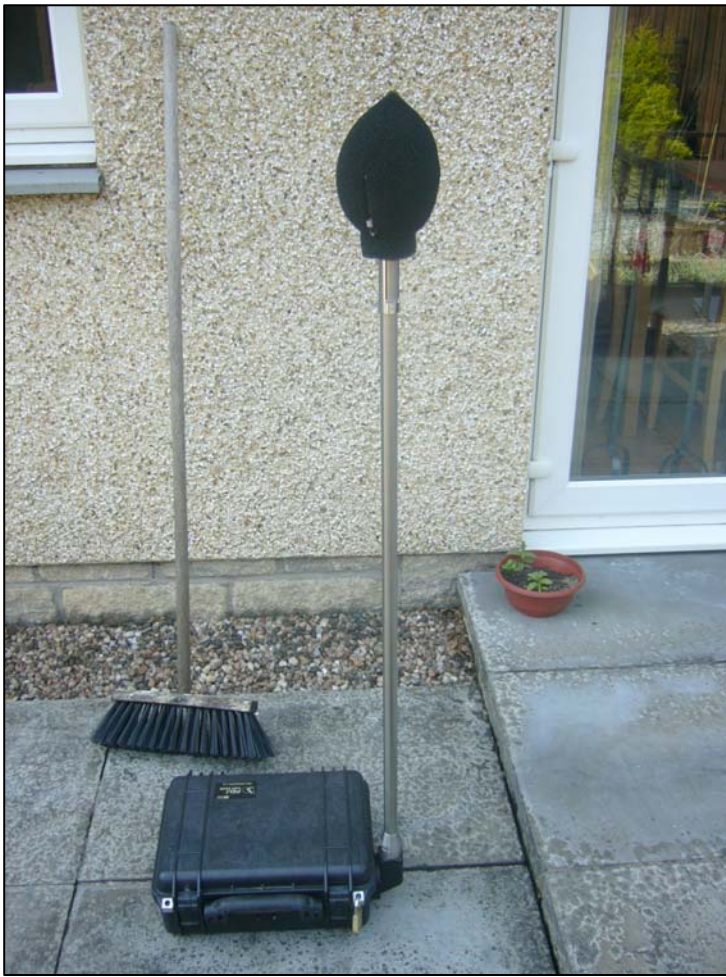
Photograph A.3: Measurement Location at 37 Moubray Gardens

The Brüel & Kjær 2250/2260 sound level meter was secured to a tripod with the microphone 1.5m above the ground, adjacent to the Rion NL-52/Brüel & Kjær 2250 sound level meter. The monitoring equipment was calibrated both before and after the measurement period using an acoustic calibrator, which has itself been calibrated against a reference set traceable to National and International Standards. There was no shift greater than 0.2 dB in the observed calibration level. Fifteen minute snapshot noise level measurements were undertaken with the Brüel & Kjær 2250 throughout the measurement procedure and are shown in Table A.3.

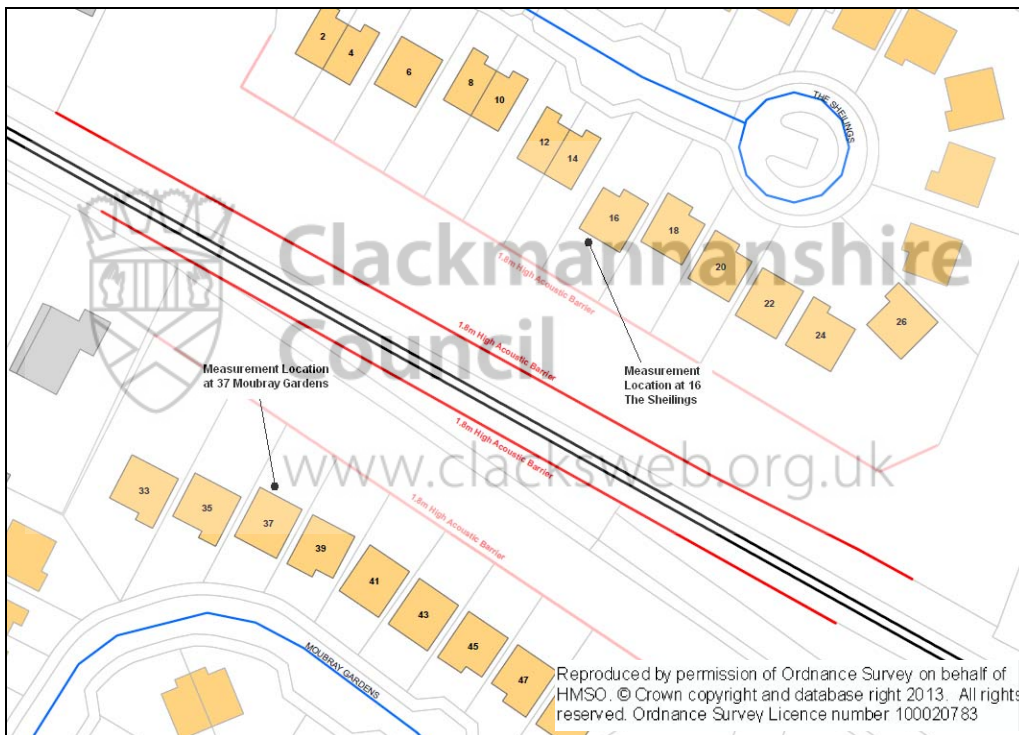
Figure A.3: Measurement Location at 37 Moubray Gardens

The measurement position was located 1m from the northern facing façade, within the rear garden area of the property. This position in turn was approximately 29m from edge of the railway line as shown in Figure A.3. The Rion NL-52/Brüel & Kjær 2250 sound level meter was secured within a weatherproof box with the microphone positioned 1.5m above the ground, see Photograph A.3. The noise monitoring equipment was calibrated both before and after each measurement period using an acoustic calibrator, which has itself been calibrated against a reference set traceable to National and International Standards. There was no shift greater than 0.2 dB in the observed calibration level. The sound level meter was secured at the property and left continuously logging throughout the measurement period.

The dominant noise at this location, excluding rail traffic movements, was distant road traffic noise from the A907 and surrounding local roads, birdsong and occasional noise from people in the garden areas of the surrounding properties.
